Manhole Inspection Summary

Manhole # S25CC_008MH

Insp Date: **10/17/07 8:41 AM**

Location Address: **1149 CAROLLTON AVE**

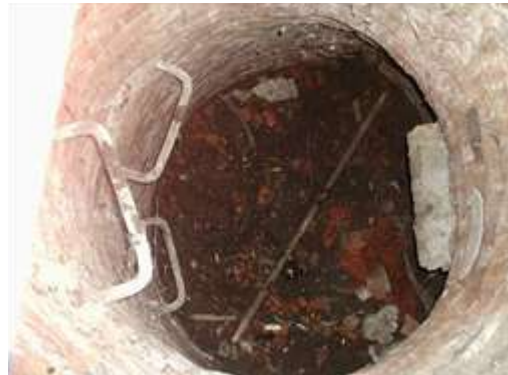
Top View

Channel debris.

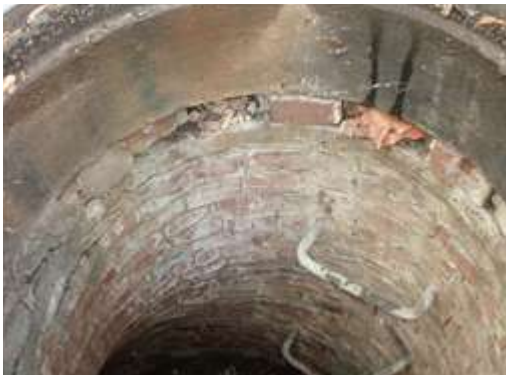
Defect

Frame leaks. Adjustment deterioration, loose brick and infiltration. Barrel infiltration.

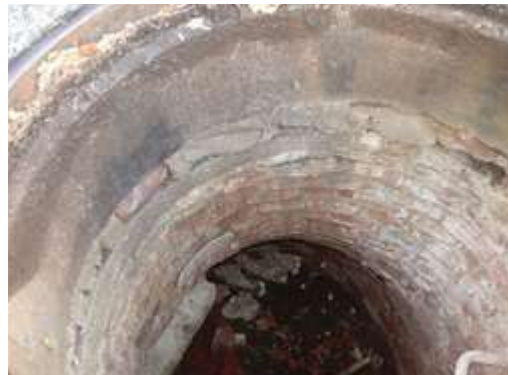
Defect

Frame leaks. Adjustment deterioration and infiltration. Barrel infiltration.

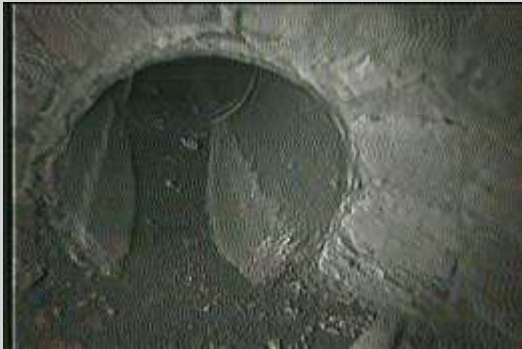
8 in. Circular Gravity Sewer
Pipe Out @ 12 O'Clock

Deposits: ☐ None ☒ **Mud** ☐ Sludge ☒ **Debris** ☐ Grease

Silt Depth: **0.5** (in.) Deposits Extent: **Light**

Infiltration: **Evidence** Pipe Seal Cond: **Cracked**
